DIAGNOSTICS GUIDE enviolo AUTOMATiQ internal gear hub

YEAR	DESCRIPTION
2022 and later	All Turbo bikes with enviolo AUTOMATiQ hubs (e.g. Vado/Como 5.0 IGH)

This checklist will help you diagnose the enviolo AUTOMATiQ internal gear hub systems on Specialized Turbo bicycles.

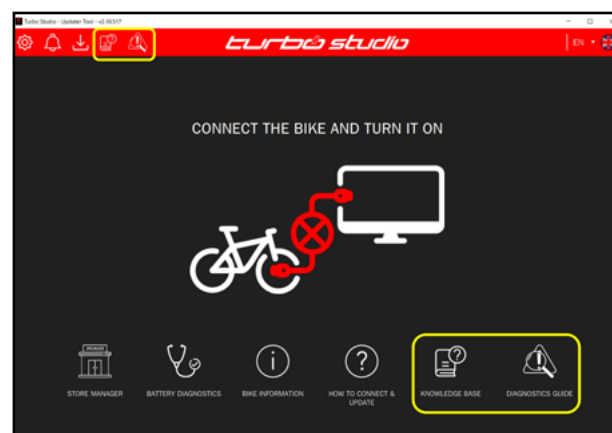
Use the icons in TS to access the Diagnostics Guide and Knowledge Base

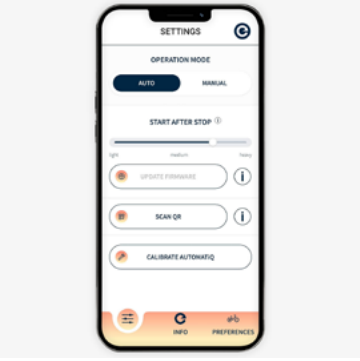
5	<p>Check general function: check for firmware updates and verify automatic setting in enviolo app.</p>

<ol style="list-style-type: none"> 1. Download the enviolo app 2. Connect app to hub interface 3. Go to SETTINGS menu 4. Run available firmware updates 5. Verify that OPERATION MODE is set to "AUTO" <p>For details on firmware updates see here, top of page.</p> <p>Context:</p> <p>"Operation Mode" set to "Manual" would lead the hub to be stuck in one gear, but after pressing the remote F2 button and selecting some cadence it goes automatically to automatic control.</p>	<p>Result 1:</p> <p>Firmware is up-to-date and setting is correctly set to "AUTO". Continue diagnostics as needed.</p> <p>Result 2:</p> <p>Firmware was outdated and/or operation mode setting was wrong; interface got updated and/or operation mode was changed to "AUTO" in app, or applied by using the remote to choose a cadence setting: correct function restored.</p>

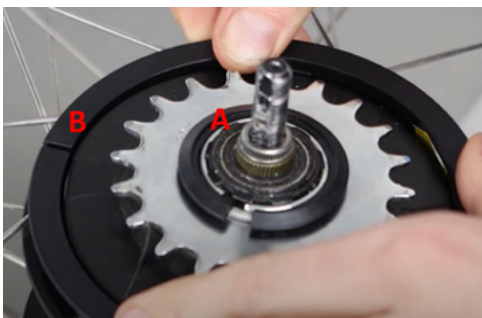
#	Action(s)	Result / Notes
3	<p>Check cadence and speed sensor functionality.</p> <p>Context: There are 2 magnet rings installed on enviolo AUTOMATiQ hubs that measure cadence and speed. Watch this video on magnet ring installation</p>

<ul style="list-style-type: none"> ▪ Cadence (A): Located over the snap ring of the rear sprocket; this ring has 12 magnets ▪ Speed (B): Located around hub shell on the drive side; larger of the 2 rings and with 6 magnets 	<p>Result 1: Magnet rings are installed, but LEDs are not blinking as intended: move to step 4.</p> <p>Result 2: A magnet ring is missing: contact enviolo for replacement.</p> <p>Testing the magnet rings</p> <ul style="list-style-type: none"> ▪ Power the bike on and rotate the cranks forward slowly ▪ When pedaling forward slowly, the hub interface LED must show a green/red pattern; this indicates both magnets are there and detected; note that the LED behaviour can vary depending on hardware and firmware version, but all types should give you a green/red pattern when both crank and hub are moving at a speed < 5ph. <ul style="list-style-type: none"> • green LED = cadence / input speed • red LED = hub speed / output speed

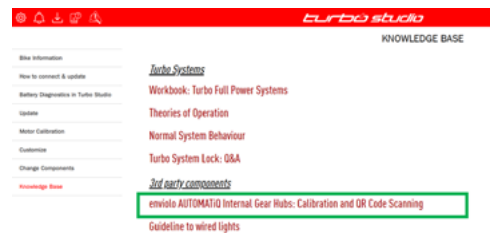
3	<p>Ensure the AUTOMATiQ interface has the correct settings applied for the bike.</p> <ol style="list-style-type: none"> 1. Open the shown Turbo Studio Knowledge Base article and familiarize yourself with the procedure of QR code scanning 2. Download and open the enviolo app, then pair to the enviolo unit. Refer to the video Download & Installation. 3. Find the correct QR code in the Turbo Studio Knowledge Base and scan the QR code under the SETTINGS menu in the enviolo app. 4. Calibrate the hub interface in the enviolo app after QR code scanning 	<p>Result 1: QR code scanning and calibration solved the issue.</p> <p>Result 2: Issue persists, hub does not provide full gear ratio: try different hub interface and/or contact enviolo service.</p>

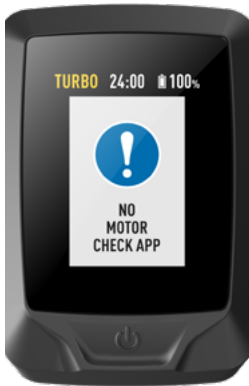
Note that this error can have a root cause unrelated to enviolo. Please use the Diagnostics Guide in Turbo Studio and check the Turbo Studio Event Log after connecting the bike to Turbo Studio.

#	Action(s)	Result / Note
1	<p>Unplug the connector at the hub interface and check both terminals for physical damage.</p> <p>Leave hub interface unplugged for this test.</p>	<p>Result 1: Error code disappears when the hub interface is unplugged: move to step 2.</p> <p>Result 2: Error code does not disappear with unplugged hub interface: issue not related to enviolo. Use digital diagnostics / the Diagnostics Guide in Turbo Studio.</p>
2	<p>Reconnect the hub interface. switch on bike, and check if “No Motor” or “Motor Error” returns on bike display.</p>	<p>Result 1: No, the error does not return when reconnected: root cause was a bad connection. Issue solved.</p> <p>Result 2: Yes, error returns on display: move to step 3.</p>
3	<p>Ensure the hub interface features the latest enviolo firmware and has the correct settings applied for the bike.</p> <p>For details on firmware updates see here, top of page. For details on QR code scanning click here, end of page.</p>	<p>Result 1: QR code scanning and calibration solved the issue.</p> <p>Result 2: QR code scanning and calibration did not solve the issue: externally test a known functioning main harness; if this solved the issue, proceed to complete installation of new main harness.</p>

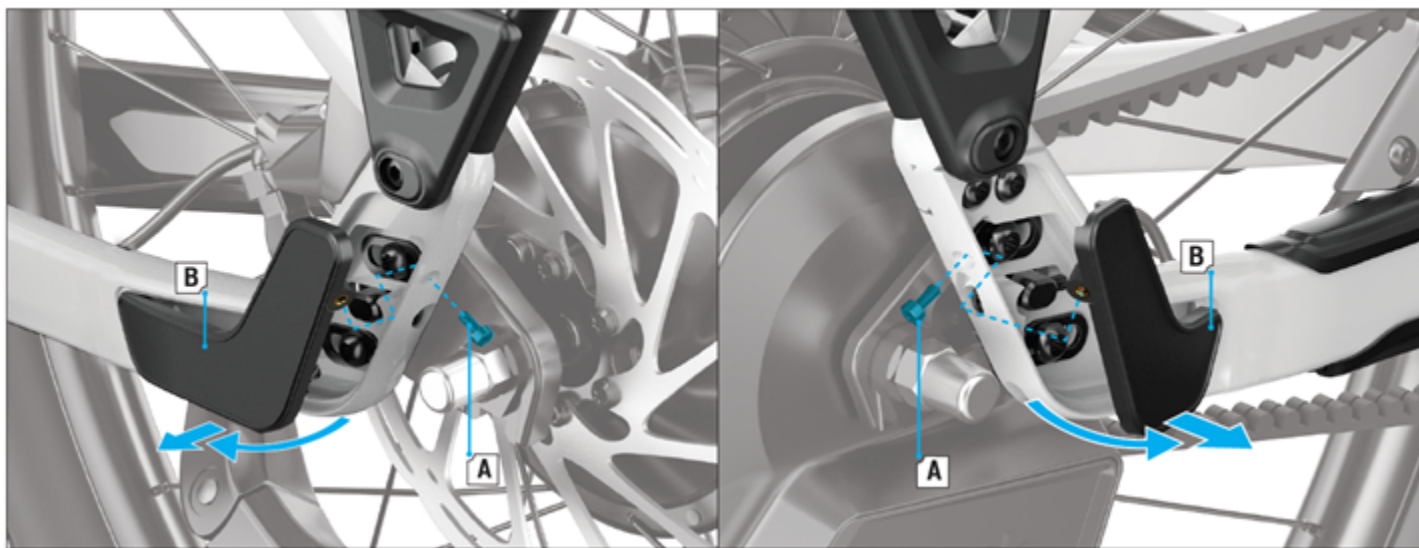
REMOVE THE DROPOUT COVERS

#	Action(s)	Result / Note
4	<p>If buzzing is constant, this is likely due to misalignment, which requires dropout adjustment.</p> <p>The following steps and images are taken from the Technical Bulletin “TURBO VADO/COMO INCORRECT BELT TENSION.”</p> <ul style="list-style-type: none"> To access the adjustable slide bolts, remove the covers located on the rear dropouts (B). Using a 2.5 mm hex key, remove both bolts from the rear of the non-drive side and drive side dropouts (A). Use a flat head screwdriver to lift the covers, then rotate the covers forward toward the front of the bike and remove them (B). CAUTION: Do not force the cover open as this damages the molded clips on the covers. Using a torque wrench and T30 Torx bit, loosen the sliding dropout tensioning bolts on both non-drive side and drive side rear dropouts (A). Using a torque wrench and a T30 Torx bit, loosen but do not remove the kickstand bolts (C). Starting on the drive side (right), use a 3 mm hex key to tighten or loosen the adjustable slide bolt (B) in small increments to achieve the correct belt tension. Always mirror each action on the non-drive side to ensure the rear wheel stays aligned. Check the belt tension by using the Bicycle Belt Tension Meter app or the Spring Tension Tester tool to ensure you have achieved the desired tension.
